June 2014

CATCHER IN THE WRONG: THE GENESIS CANISTER LIFT INCIDENT

Genesis Canister lift incident

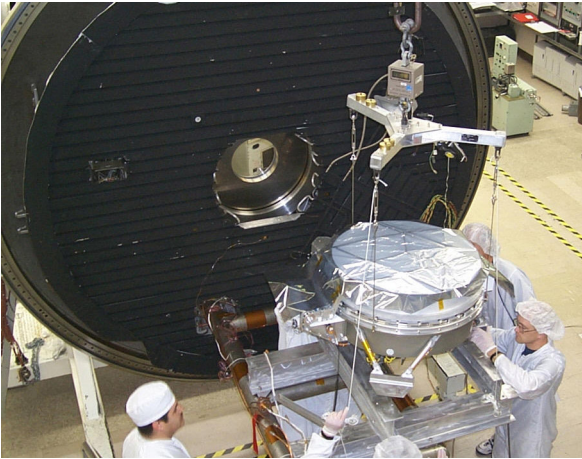
While the Genesis Canister was being lifted from the transportation dolly at JPL in preparation for thermal vacuum testing, the lift fixture detached at one of the three swivel hoist ring tension fittings (Reference 2).

Genesis Canister being lifted for mounting on the test chamber door. (The swivel hoist ring that separated from the spreader bar is visible, attached to the top of the rightmost of the three hoist cables.)

Just prior to mounting on the test chamber door, one corner of the Canister fell approximately 5 centimeters (2 inches) back onto the dolly. Nearby personnel cushioned the fall to achieve a soft landing on the dolly, and there was no damage to the canister or support equipment, or serious injury to personnel. (One of the test personnel had his finger caught between the bottom of the Canister and the transportation dolly. While he perceived the pinch to his finger, he was not injured. Some minor scratches were evident on the bottom where the Canister contacted the dolly, but no gouges were seen. The loose shackle swung and contacted one of the stiffening ribs on the Canister cover, leaving a very small ding on its corner.)

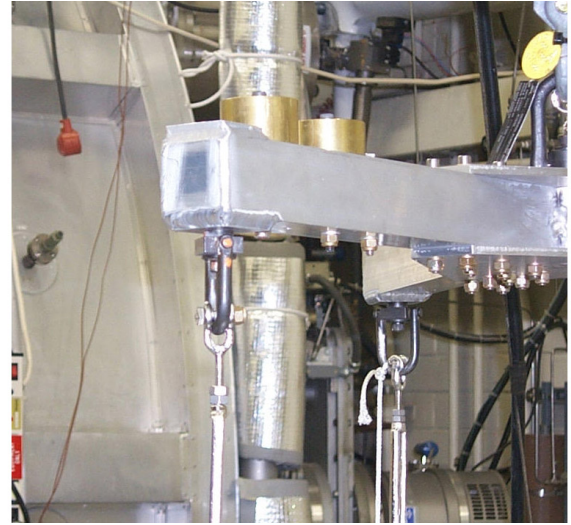
Post-incident inspection revealed that the threaded fastener had backed out of the Mechanical Ground Support Equipment (MGSE) fixture and became detached. The bolt that released had backed out at least a quarter of an inch, and this would have been easily observable. A second bolt was also backed out, but not as far. Additionally, the fasteners at the other tension fittings, and at the upper hoist point, were found to be only hand-tight.

Close-up of the swivel hoist ring fitting

The fixture was visually inspected prior to the drop incident, but the hoist rings were not checked for tightness. There is no evidence that the hoist ring fasteners had been properly torqued since the proof test. The procedure governing the Canister lift operation (Reference 3) did not require adequate checking of all fasteners prior to attaching the fixture to the hoist.

6. What measures might have facilitated visual inspection of the MGSE, such that the un-torqued fasteners could be spotted? [The fastener heads could be torque-striped to enhance visual inspection of thread engagement.]

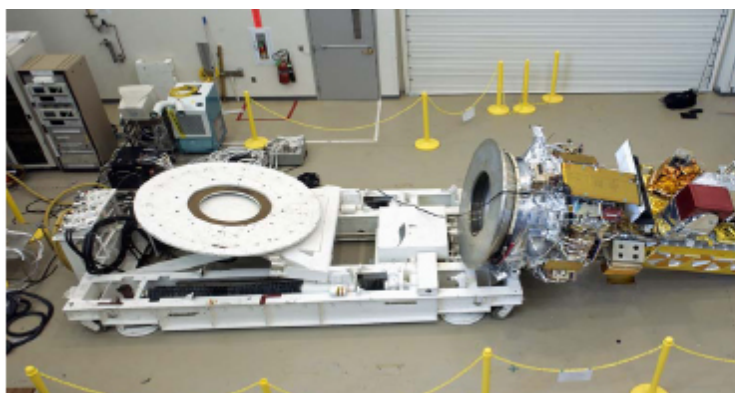
A mishap occurred to a NASA Goddard Space Flight Center managed system at a non-NASA facility. During a September 2003 procedure, rotating the Television Infrared Observational Satellites (TIROS) National Oceanic and Atmospheric Administration (NOAA) N-Prime satellite was required. As the satellite was being rotated from a vertical to a horizontal position, it toppled from the Turn-Over Cart (TOC) and fell onto the concrete floor (Figure 1). Although no personnel were injured, the satellite sustained heavy damage (Figure 2).

Figure 1. NOAA N-Prime satellite fell off the Turn-Over Cart

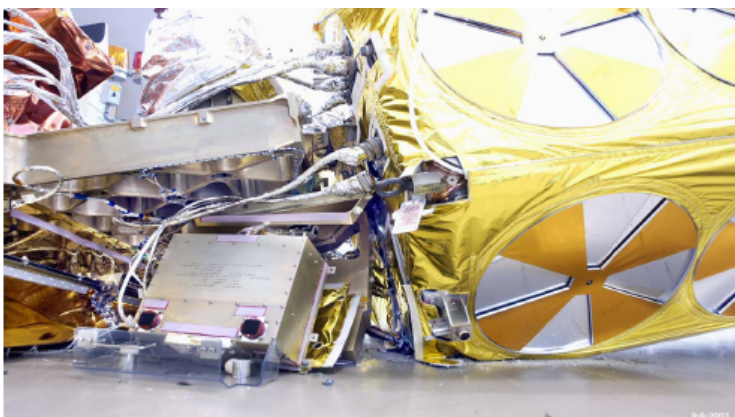
Figure 2. NOAA N-Prime sustained heavy damage

A planned addition to a series of global weather forecasting satellites, N-Prime was in an advanced stage of testing when the mishap occurred. Damage to the chassis, components, and at least 2 of the 6 instruments was estimated at \$135 million (Reference (2)).

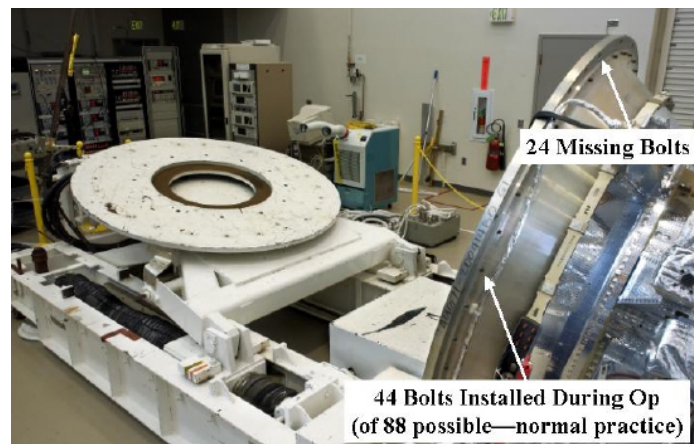
The planned procedure was to remove and reinstall one of the instruments onboard the satellite. This procedure required the satellite to be tilted to the horizontal position using the TOC. The satellite fell to the floor as it reached 13 degrees of tilt. The proximate cause of the fall was the failure of the operations team to follow procedures for configuring the TOC: the 24 bolts that secure the satellite's TOC adapter plate to the TOC (Figure 3) were not installed and inspected (Reference (1)). While the TOC was in a common staging area, another project had removed the 24 bolts from it, an activity that was not communicated to the NOAA project team.

Figure 3. The 24 bolts used to secure the satellite to the TOC were not installed
